Here are some readings from my 2018 Ford Everest [same electricals as PX Ranger]

So.... I've run some tests measuring Volts, Amps & SOC for Single Battery, 90% Dual Battery & 100% Dual Battery - See attached output

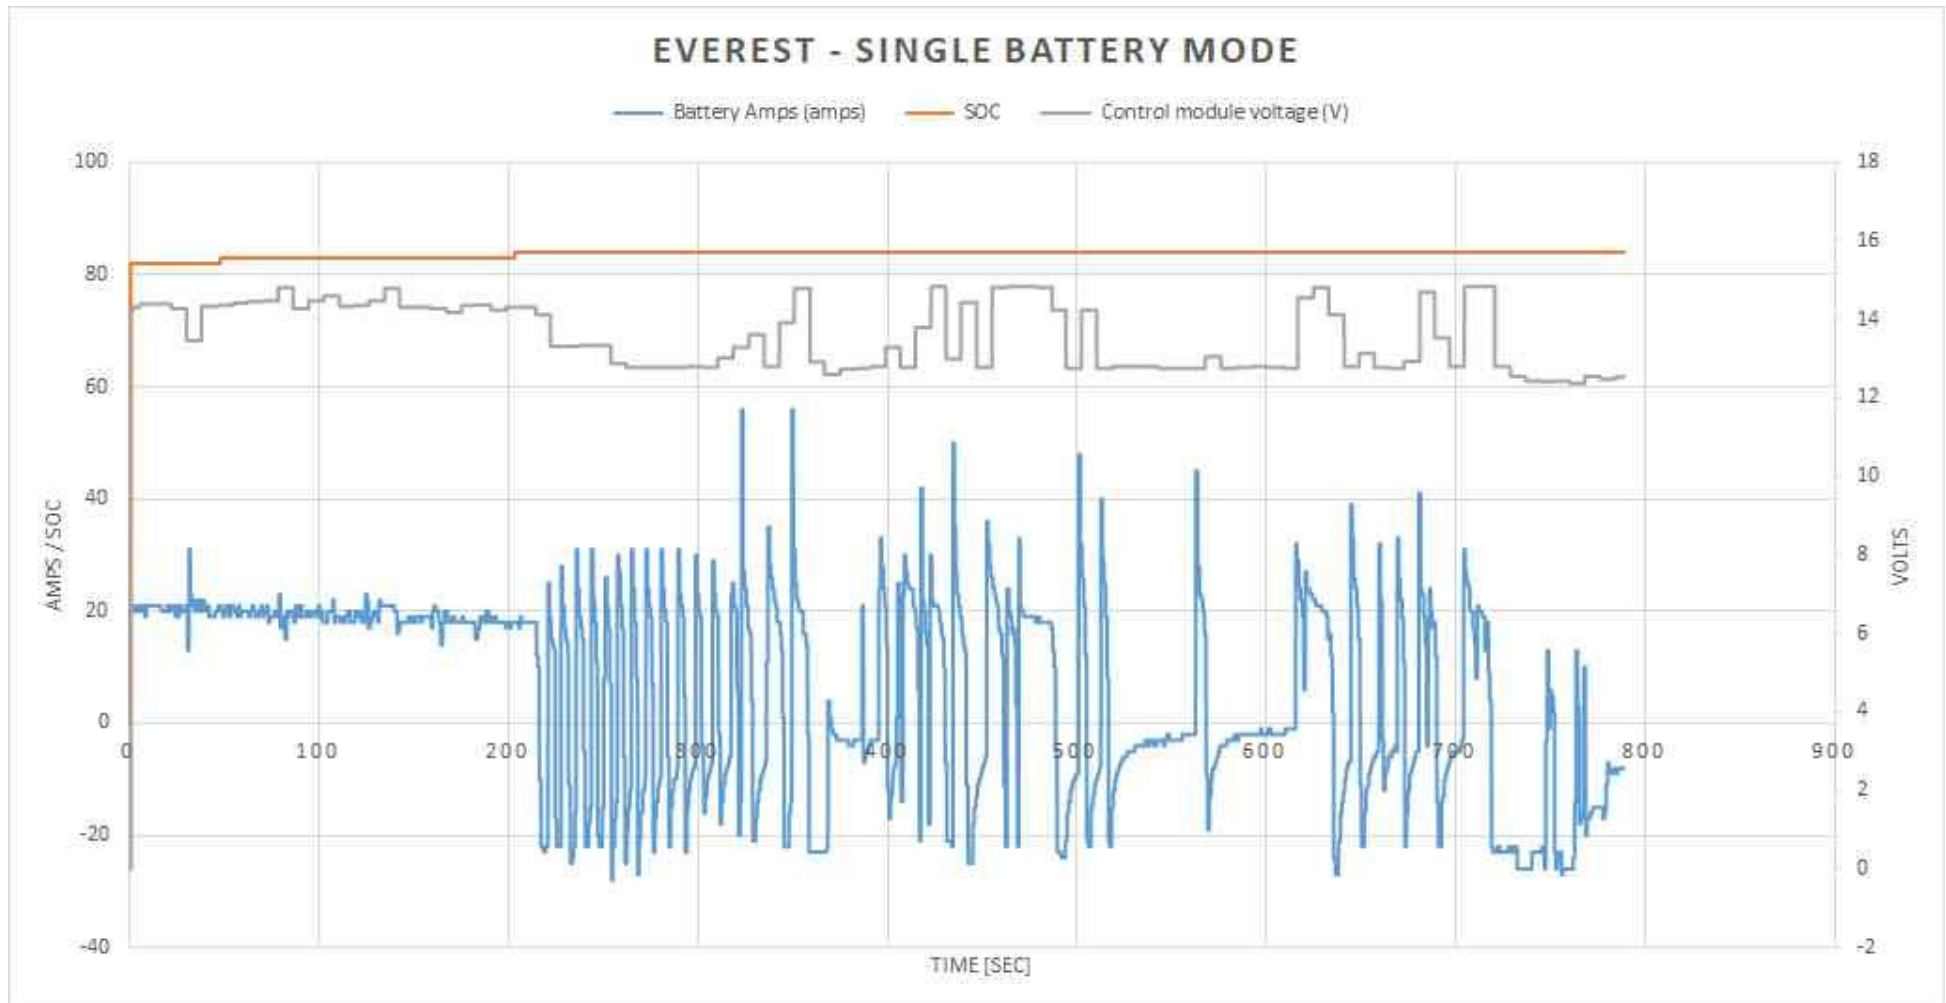
Single battery charges to around 85% SOC and then the alternator starts to cut in and out with charge fluctuating [+ -] 20 Amps in a very erratic manner. Is this normal? - have others experienced this erratic charging behaviour? I would have expected a smoother response from the alternator.

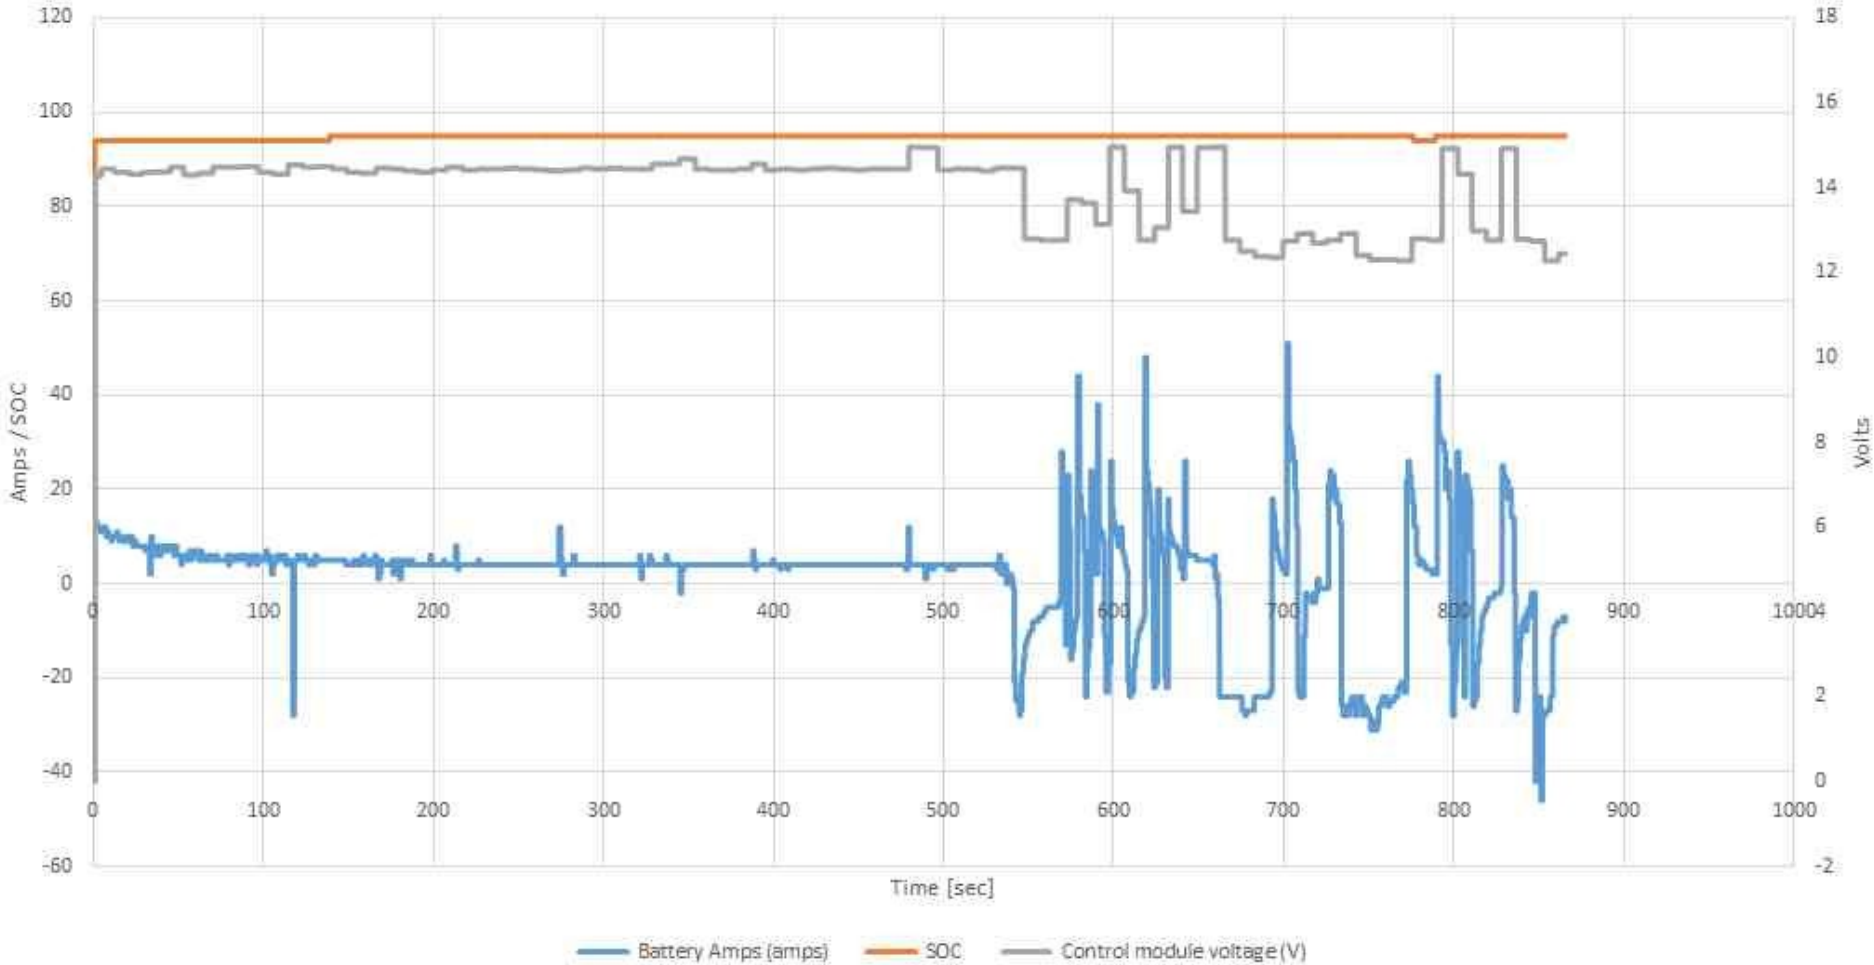
Everest - Dual Battery 90%

Dual Battery 90% has a similar behaviour - but charging to about 95%. It would appear that the BCM is monitoring the SOC and cutting the alternator voltage when the target SOC is reached.

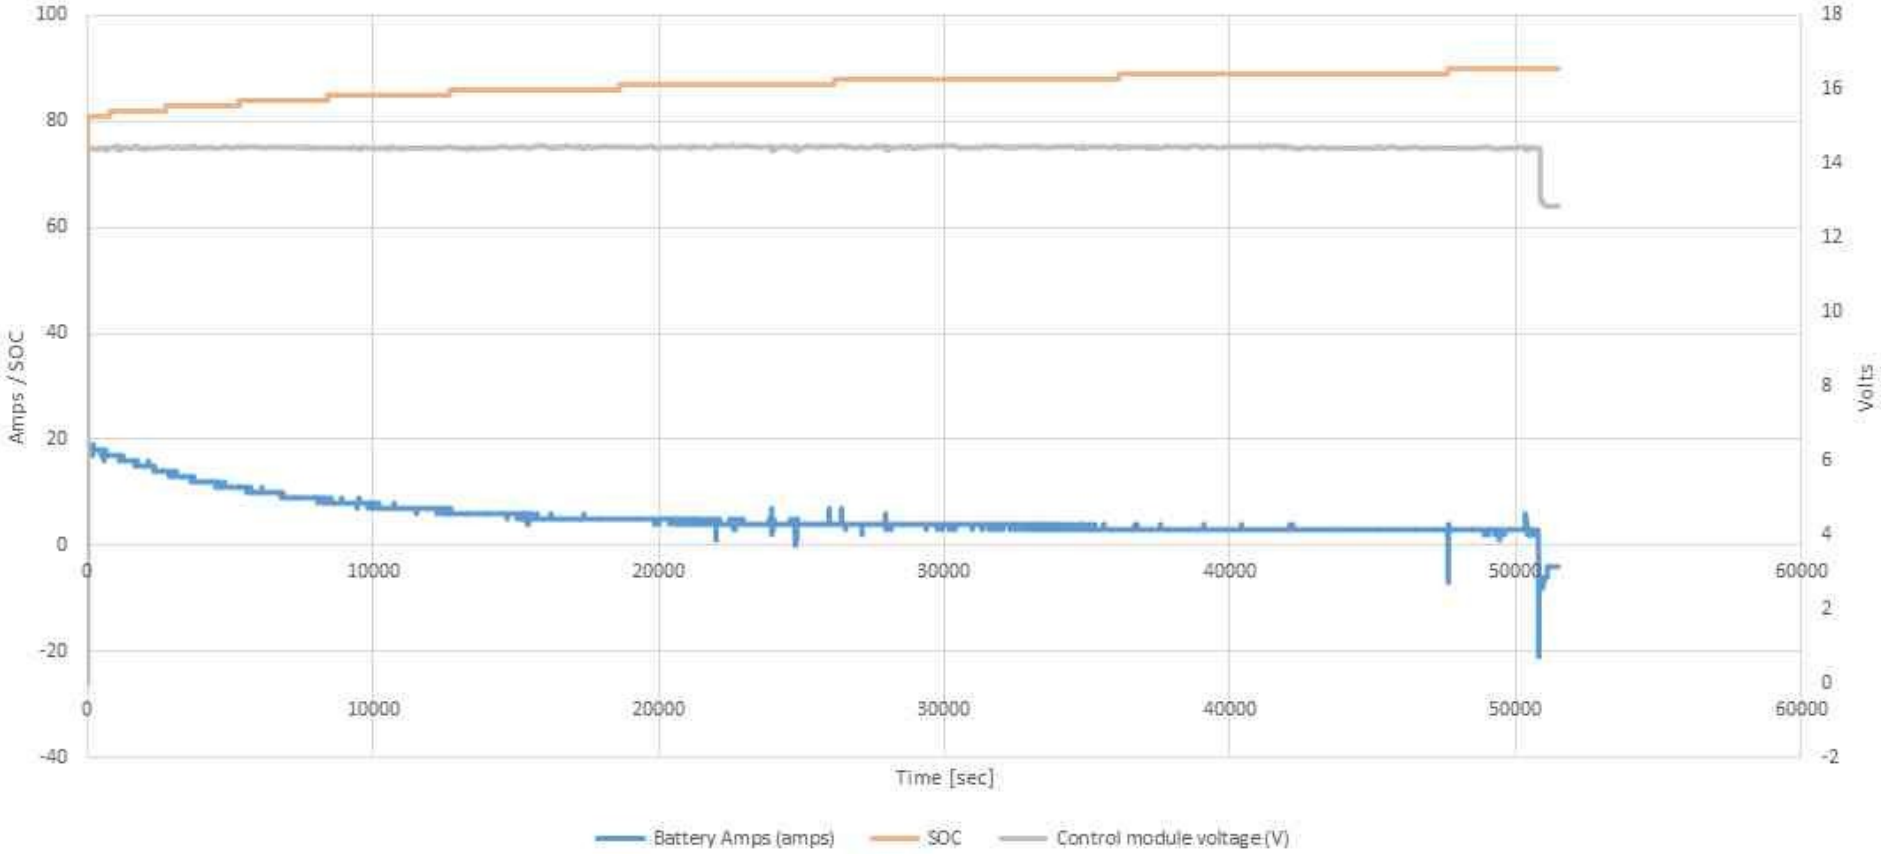
Everest - Dual Battery 100%

Full Dual Battery 100% Shows much smoother charging with a constant 24/7 14.4 Volts & Amps slowly reducing as the battery slowly reaches maximum charge as you would expect. It did not reach 100% SOC this run - bit over 90%, but it did before & I expect with constant 14.4 V charging it will eventually reach 100% again.
